Manhole Inspection Summary

Manhole # S69Y__001MH

Location Address: **BECKLEY ST.**

Cross Street: **VAN DEMAN ST.**

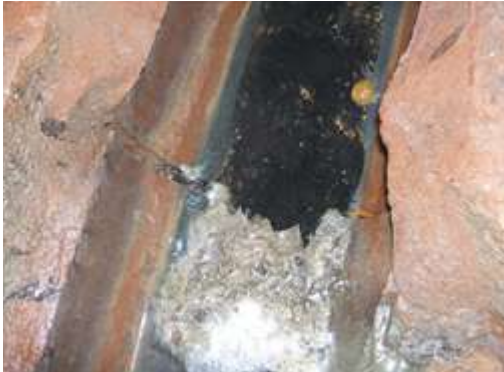
Defect 1

Comments **NRV2 - CRACK IN CHANNEL PIPE JOINT. THIS MANHOLE COVER WAS PREVIOUSLY STUCK. OPENED BY CITY.**

Condition: ☐ Sound ☒ **Cracked** ☐ Root Intrusion ☐ Deteriorated ☐ Leaks ☒ **Debris**

SEPARATED JOINT IN CLAY PIPE CHANNEL

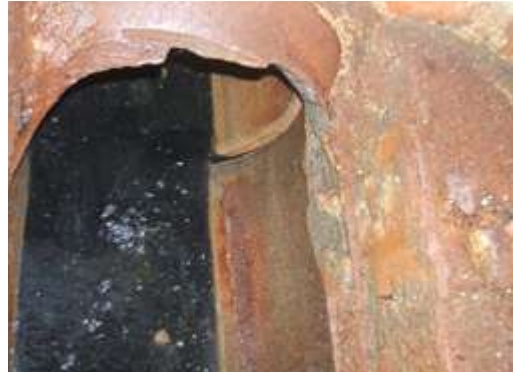
Defect 2

CRACKED PIPE SEAL I6

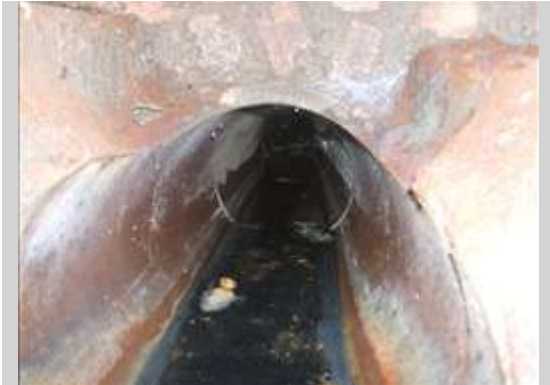
12 O'Clock Outflow

12 in. Circular Gravity Sewer
Pipe Out @ 12 O'Clock

Pipe Height: (in.) Direct
Pipe Material: **Clay** ☐ Pipe Lined
Invert Depth: **8.07** (ft.) Flow Characteristics: **Slow**
Deposits: ☐ None ☐ Mud ☐ Sludge ☒ **Debris** ☐ Grease
Silt Depth: **1.5** (in.) Deposits Extent: **Medium**
Infiltration: **None** Pipe Seal Cond: **Sound**

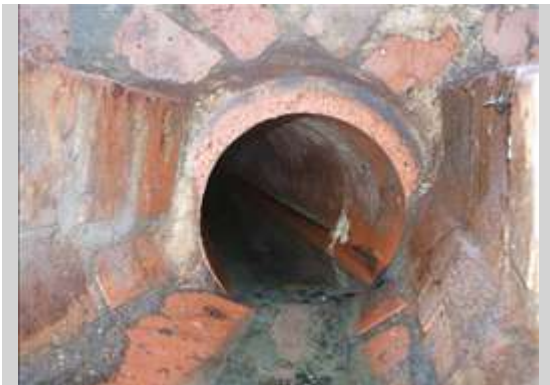
4 O'Clock Inflow

8 in. Circular Gravity Sewer
Pipe In @ 4 O'Clock

Pipe Height: (in.) Direct
Pipe Material: **Clay** ☐ Pipe Lined
Invert Depth: **7.70** (ft.) Flow Characteristics: **Slow**
Deposits: ☐ None ☐ Mud ☐ Sludge ☒ **Debris** ☐ Grease
Silt Depth: **1.5** (in.) Deposits Extent: **Medium**
Infiltration: **None** Pipe Seal Cond: **Sound**

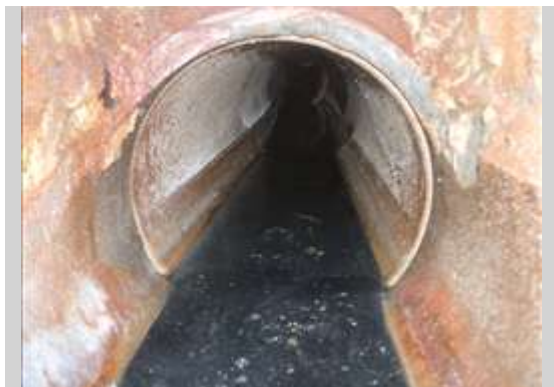
6 O'Clock Inflow

12 in. Circular Gravity Sewer
Pipe In @ 6 O'Clock

Infiltration: **Evidence** Pipe Seal Cond: **Cracked**
